## Property Inspection Report

**123 Elm Street  
Humble, TX 77338**

By: **Joe Fleet, TREC Lic. #8674** **10/7/2010**  
(Name and License Number of Inspector) (Date)

## Report Identification: SAMPLE INSPECTION REPORT

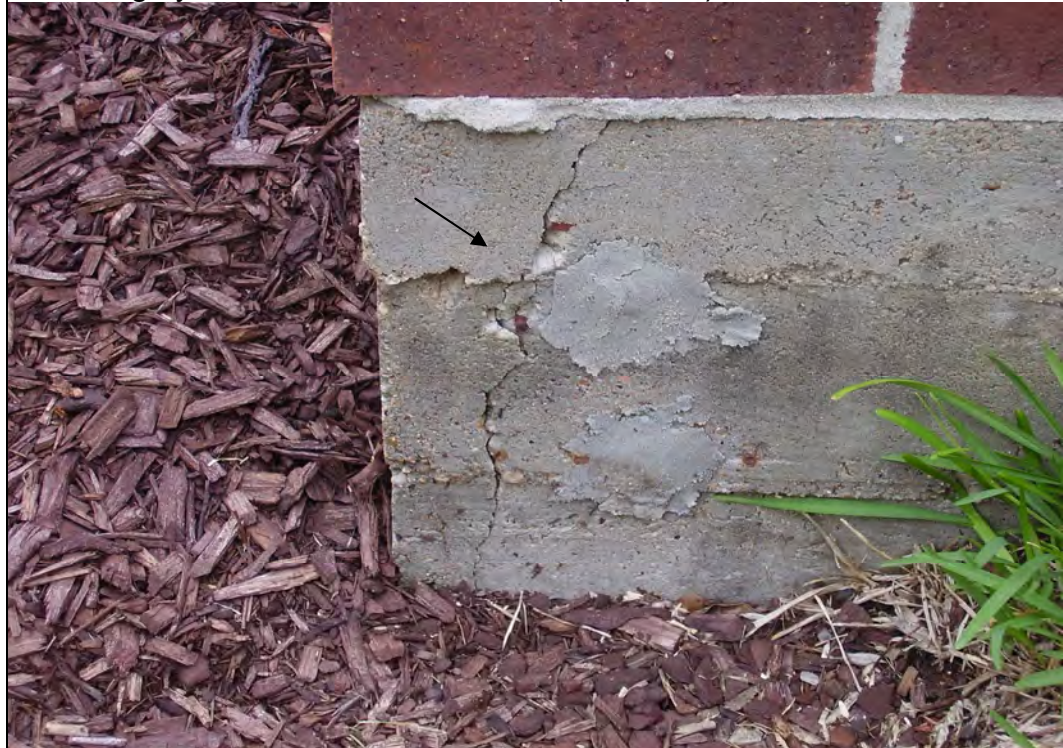
Comment - A spalling crack was noted at the NE corner of the slab. These types of cracks are cosmetic in nature only, and do not affect the structural integrity of the homes foundation (see photo).

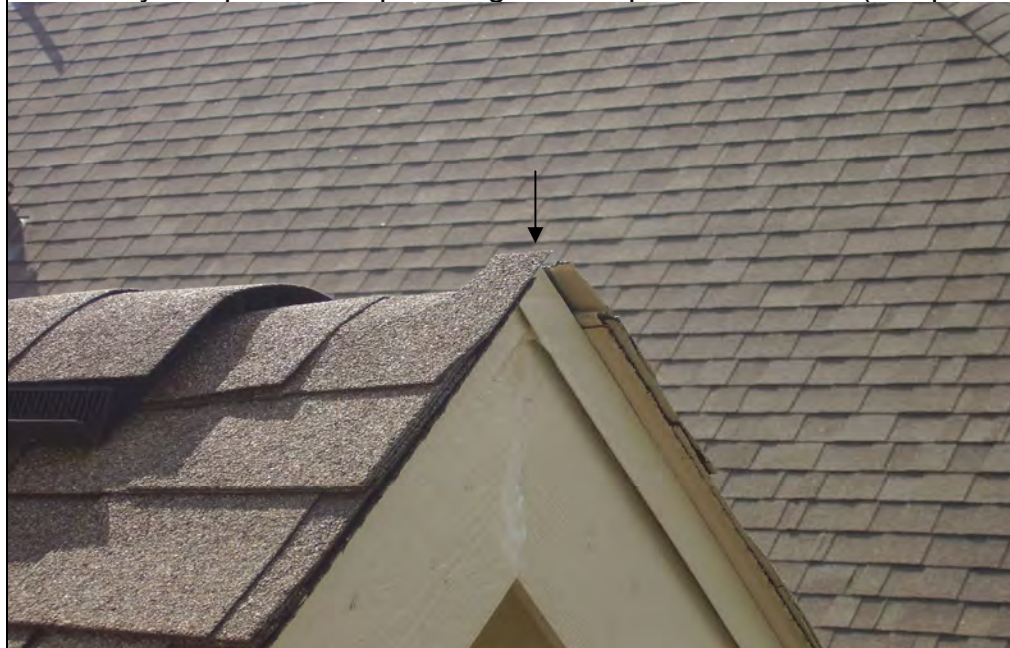
Comment - The roof covering appears to be a 30-year, Class A composition shingle, installed over plywood decking, approximately five years old  
Deficiency - Replace the split shingle at the peak of the roof (see photo).

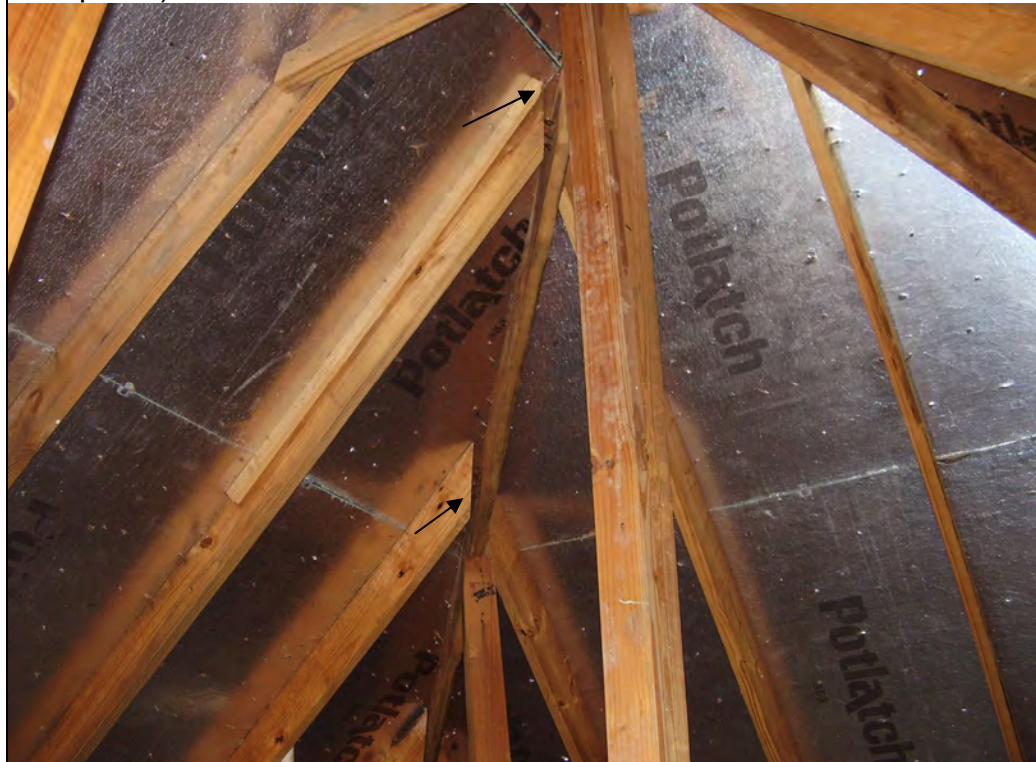
Comment - Conventional attic framing, that consists of rafters and joists with a purlin system, is present  
 Deficiency - Two jack rafters have greater than 1" gaps to the hip rafters in the attic. Jack rafters can be scabbed with a similar dimension board, running flush along the jack rafter and toe nailed to the valley rafter, to correct (see photo).

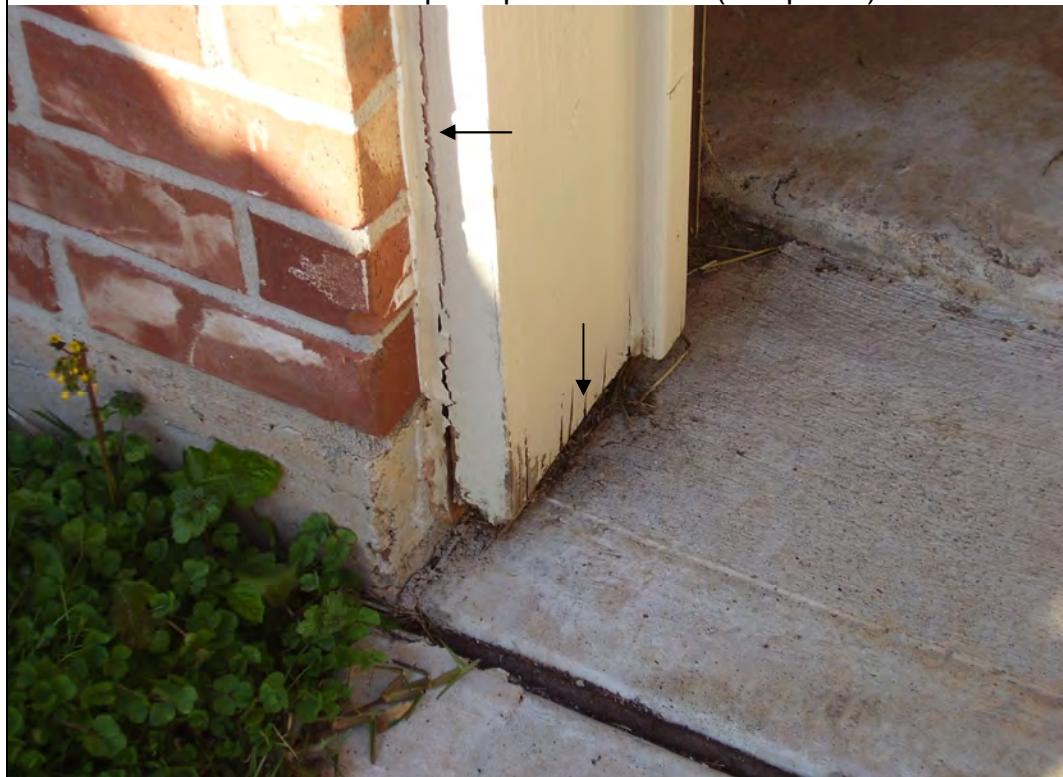
Deficiency - Deterioration was noted at the bottom of the garage door jamb boards that needs repair. In addition, the vertical gaps noted at the boards should be caulked to help keep out moisture (see photo).

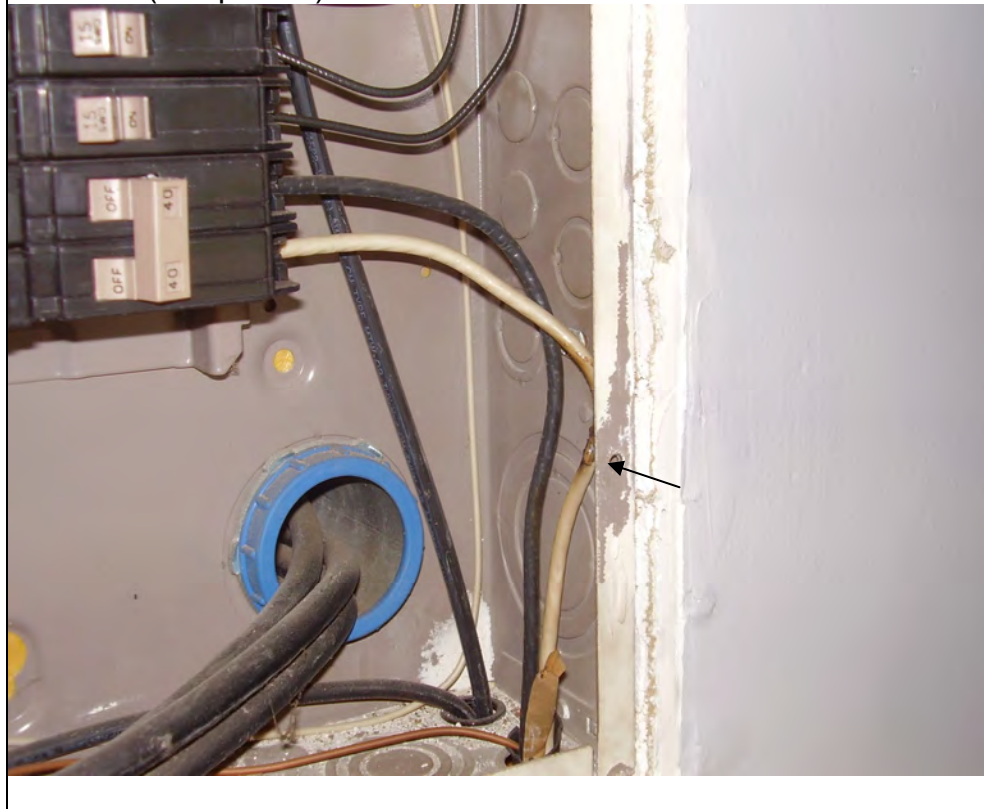
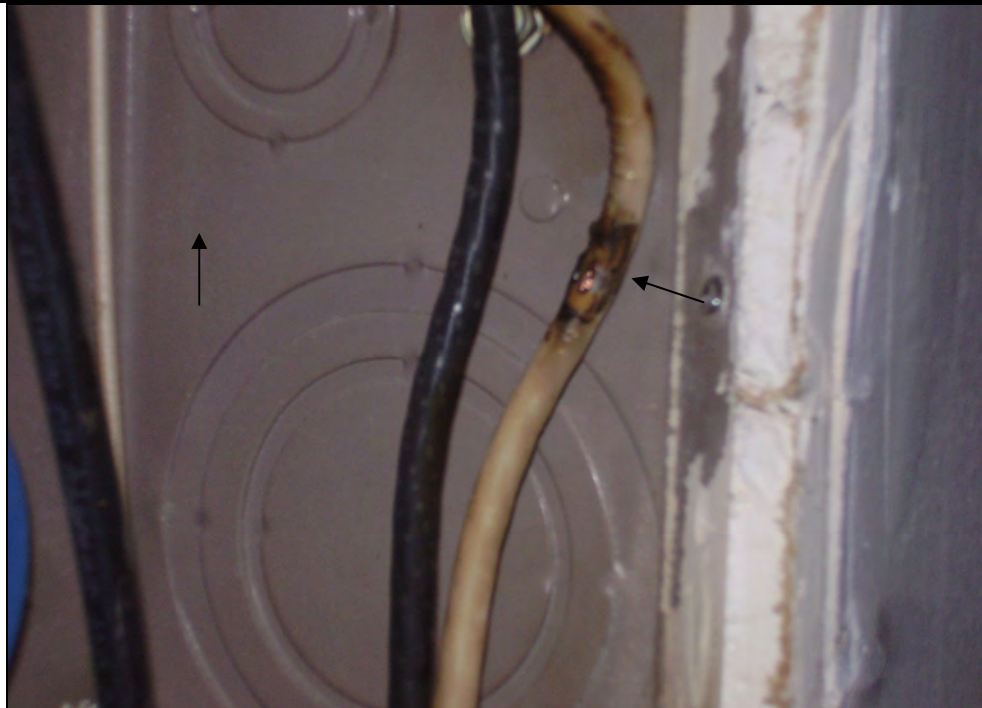
Deficiency - Repair/replace the burnt wiring noted at the lower right in the electrical box. It appears pointed-tip screws have been used erroneously, which have penetrated the conductor wire, requiring replacement of the wire (see photos).

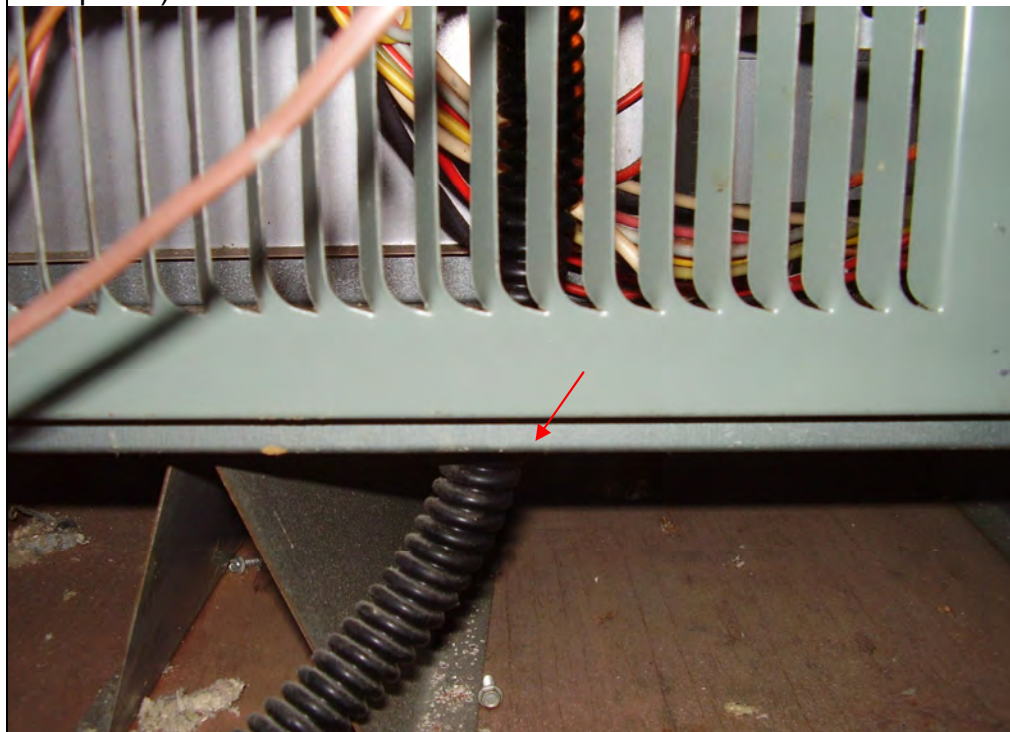
Deficiency - The gas line should be hard piped where it passes through the furnace housing. Flex gas lines are susceptible to being cut open by the sheet metal housing of the furnace, if the unit vibrates while operating (see photo).

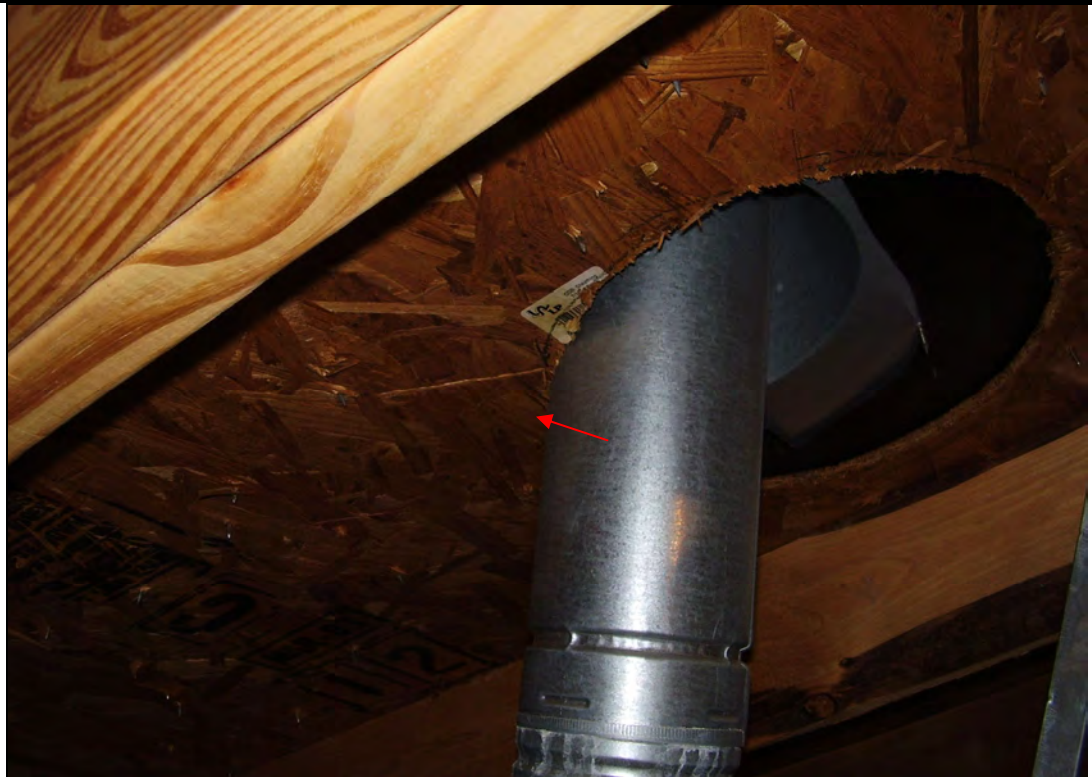
Deficiency - The exhaust vent pipe should have a minimum 1" clearance where it passes through the wood roof sheathing. In addition, the pipe should be secured to the rafters with a metal strap (see photo).

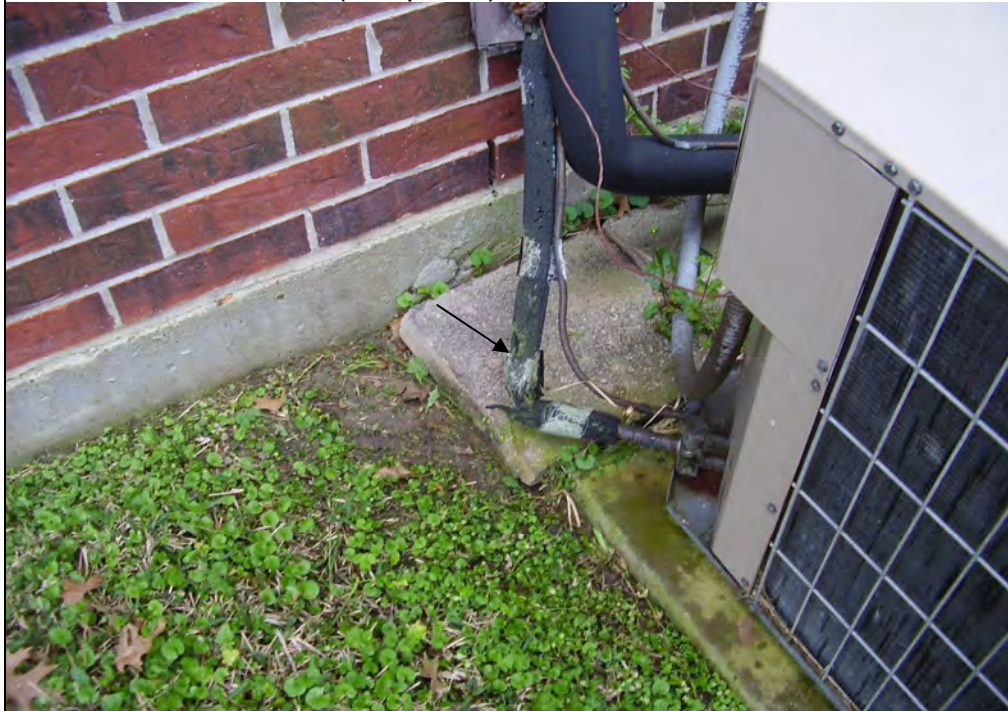
Comment - The air conditioner exhibited a proper temperature drop (a minimum of 16 degrees) across the coil to cool sufficiently at this time.  
Deficiency - Replace the deteriorated/missing insulation on the low pressure line at the exterior AC (see photo).

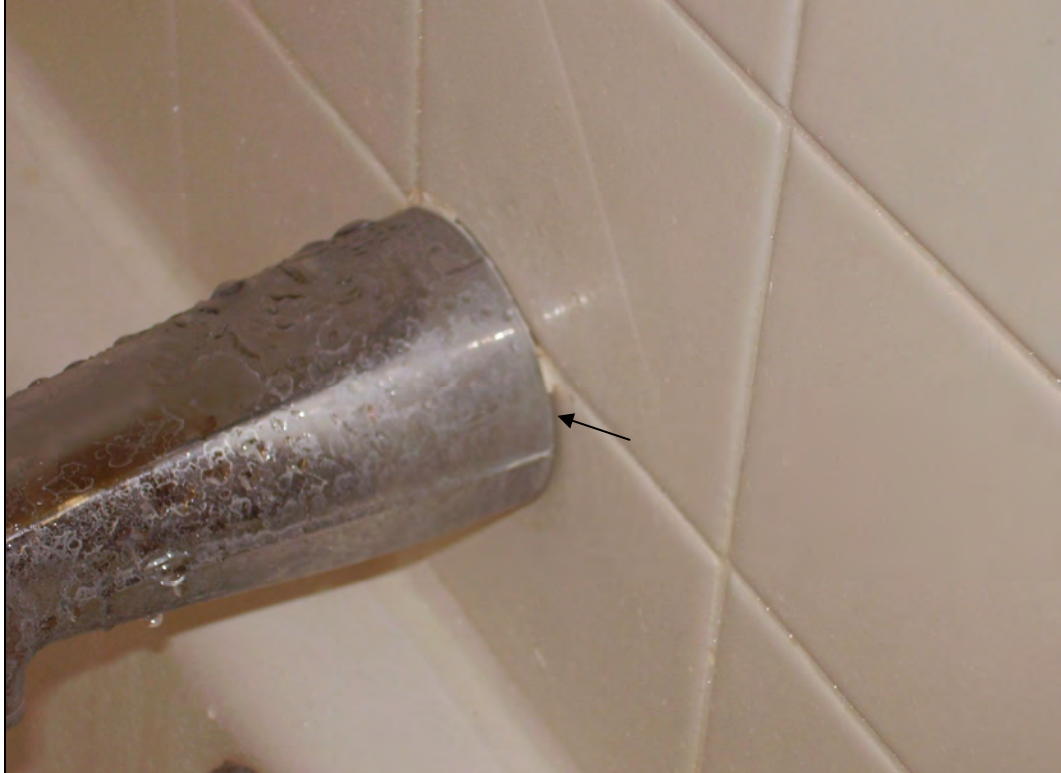
Deficiency - Seal the gap noted around the tub spout at the shower wall to help keep out moisture (see photo).

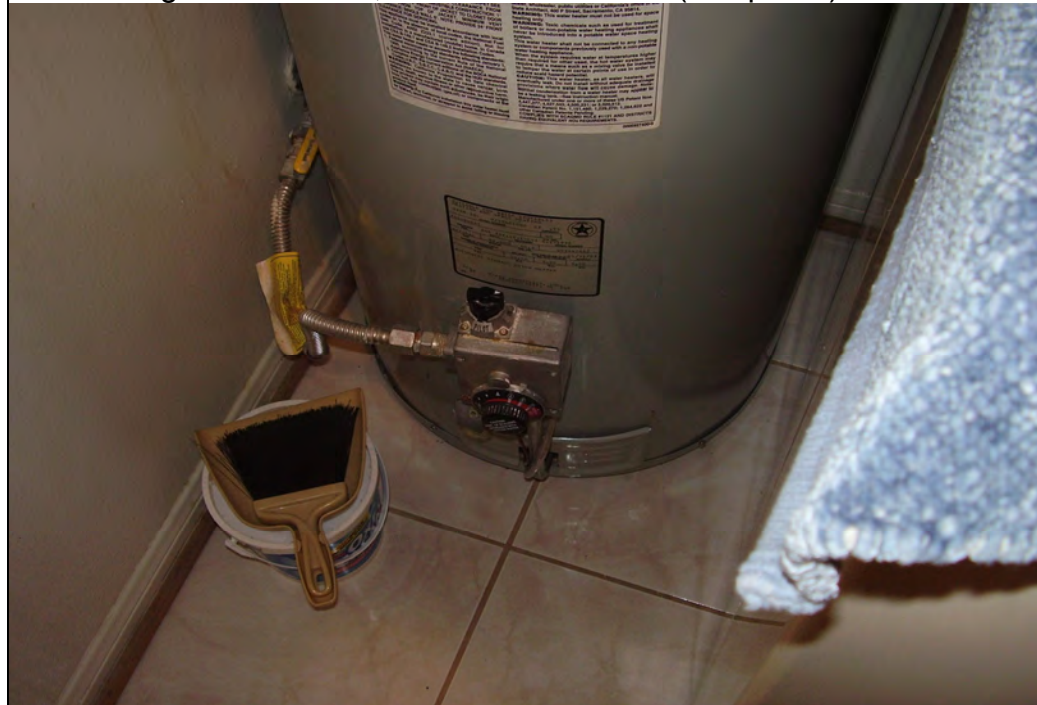
Deficiency - Install a safety pan beneath the unit (with drain line) to prevent damage to the home, should the unit leak (see photo).
